EXHIBIT A

Smoke Test Reports

**Critical Sanitary and Storm Sewer Improvements Contract Section 01532E –
Smoke Testing City of Atlanta**

Re: 1071 Piedmont Ave. Sewer Investigation & Findings

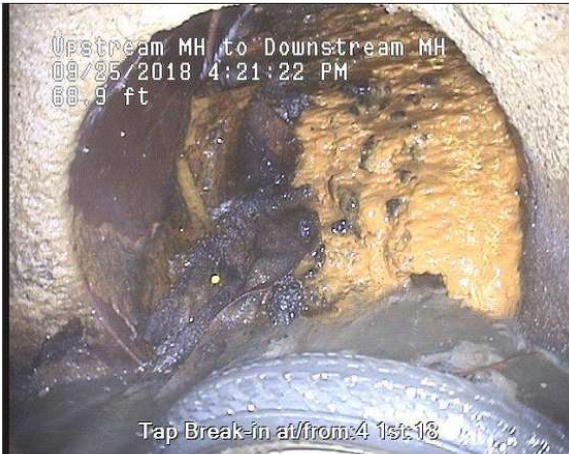
Upstream MH_1619003.jpg

Dist (ft)	Counter	PACP code
68.9	169	TB

Tap Break-in
