FIELD REPORT

PGC Project No: 117502

Project: Soulshine Renovations

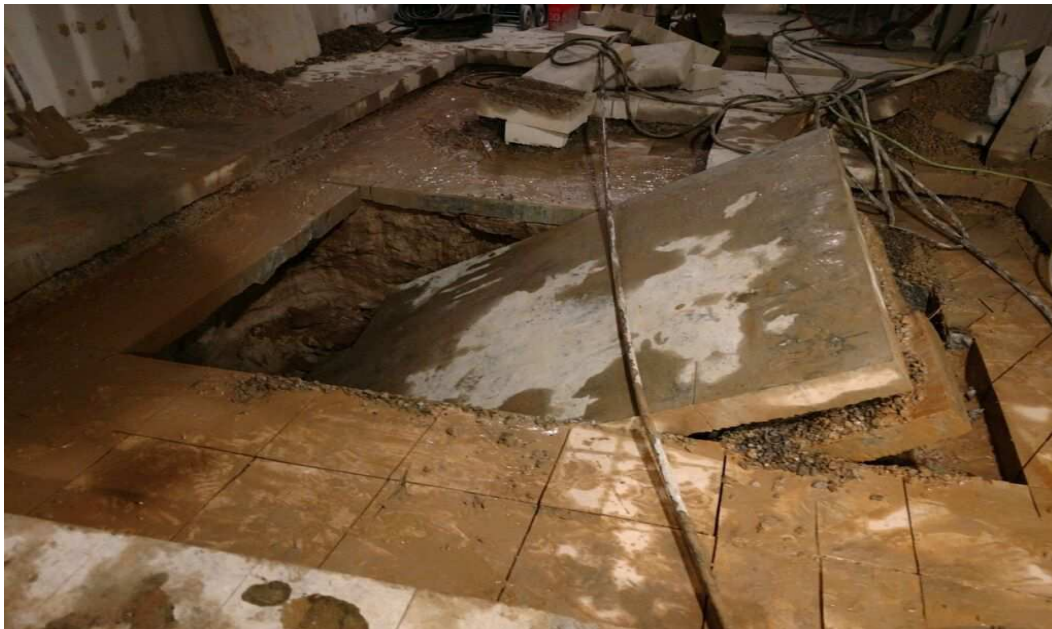
The undersigned was onsite as requested by the contractor to evaluate a **loss of ground/void beneath the slab that was discovered during demolition.** Upon arrival the existing slab and topping slab section that was saw cut for removal had fallen into a large hole beneath the slab. The subsidence area is approximately 6 feet long by 10 feet wide. From review of older construction plans there appears to be a sanitary sewer which runs beneath this building. One page in the plans identifies the line as an "old rock sewer". At this time it appears the loss ground may be caused by damage to this sewer line and flows through the sewer eroding soils above the pipe. **We recommend having the pipe videoed to identify damage to the pipe at this location and any other location beneath the structure.** The structural engineer should also be notified in the event that additional/temporary foundation support is needed. **Based on measurements at the upstream and downstream manholes, it is likely that if the sewer is the cause of the loss of ground, excavations to repair the pipe could be as deep as 16 or more feet.** The photo below show the cut slab sections fallen into the void.
