Re: Sink hole Soulshine

Soulshine Sinkhole Pictures

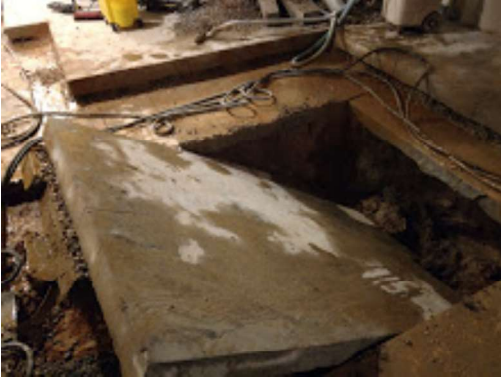
IMG_20180711_215114467_LL.jpg
5559K

Please see attached sinkhole pictures. It difficult to tell via the pictures but the hole is definitely growing. Chris Fisher, our site super, has been monitoring the erosion on a daily basis. It's not eroding at great rate, but it is steadily growing which is a concern. Pictures 4467, 8765, & 8688 were taken when we discover the hole (July 1st +/-). Pictures 7880 & 9989 were taken earlier this week.

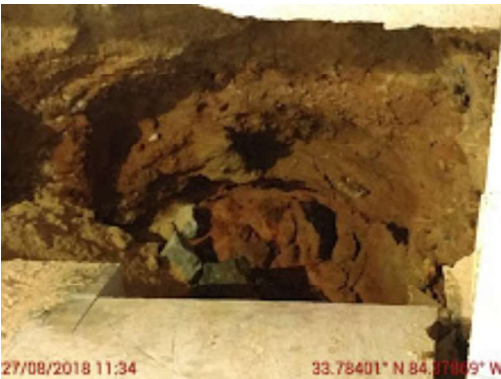
IMG_20180827_104217880_LL.jpg
1409K

To add to Scott's information, as he stated, the depth of the hole is hard to determine as the slabs are in the way of an accurate measurement of the depth. The slabs have dropped at the west end about 6" since discovered in July. The south and north walls that can be seen have not deteriorated much. The west wall however has had the most change. As Scott mentioned we placed a control board to measure from and it shows approximately a 5-7/8" Change in the last 2 weeks with a width change of an overall 36". The possible cause is vibration from the street and daily activity in the building. Also that the city placed water in the hole for testing purposes has made the materials relatively moist.
